Manhole Inspection Summary

Manhole # S25E__013MH

Insp Date: **4/7/09 1:13 PM**

Location Address: **1001 CARLTON ST**

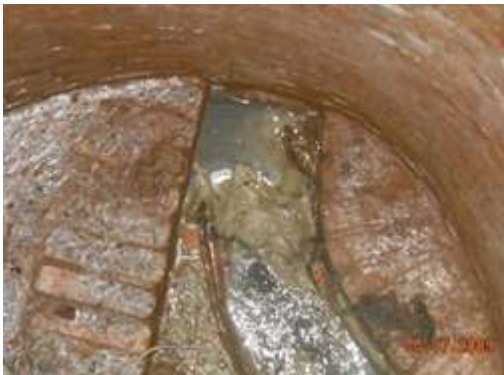
Defect 5

Condition: ☐ Sound ☐ Cracked ☐ Root Intrusion ☐ Deteriorated ☐ Leaks ☒ **Debris**

THERE WAS DEBRIS IN THE CHANNEL AFFECTING FLOW

Comments **LID CUT OPEN BY SAW ON 4/3/09 REPLACED WITH NEW 24" SANITARY LID. 1/2 HOUR OF SPECIALTY CLEANING REQUIRED TO RESTORE FLOW IN MANHOLE. INSPECTION COMPLETE.**

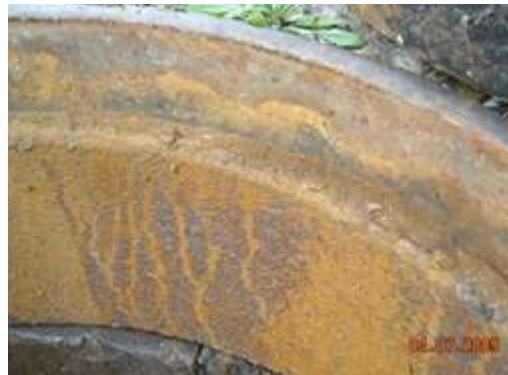
Defect 4

Frame Offset: **3** (in.) Condition: ☐ Sound ☐ Cracked ☒ **Leaks**

EVIDENCE OF INFILTRATION - FRAME LEAKS

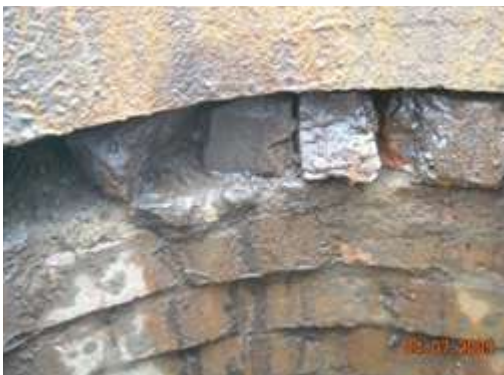
Defect 3

Condition: ☐ Sound ☒ **Cracked** ☐ Root Intrusion ☒ **Loose Brick** ☒ **Deteriorated**

DETERIORATED CHIMNEY WITH LOOSE AND MISSING BRICKS

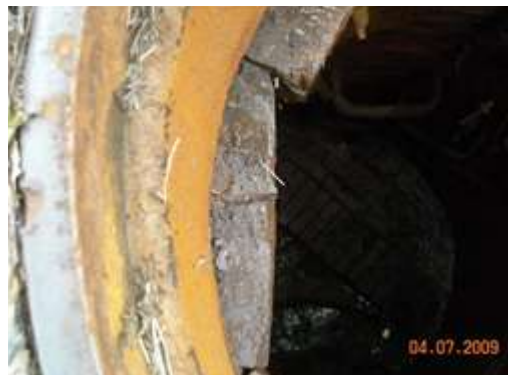
Defect 2

FRAME OFFSET 3"

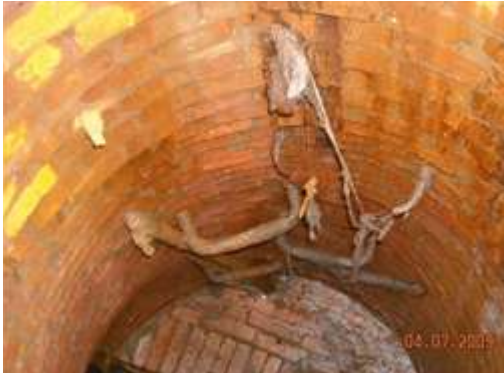
Defect 1

Steps Count: **3** Missing: **2** ☒ **Corroded**

CORRODED AND MISSING STEPS

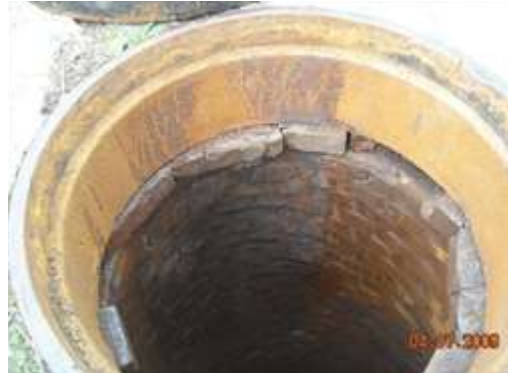
Defect 6

EVIDENCE OF INFILTRATION DUE TO SHEETING

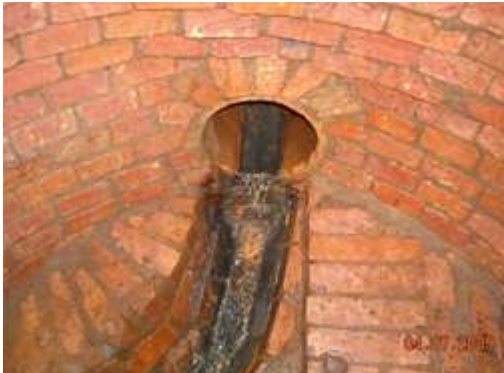
Defect 7

Condition: ☐ Sound ☐ Cracked ☒ **Root Intrusion** ☐ Loose Brick ☐ Deteriorated

ROOT INTRUSION IN BARREL WALL

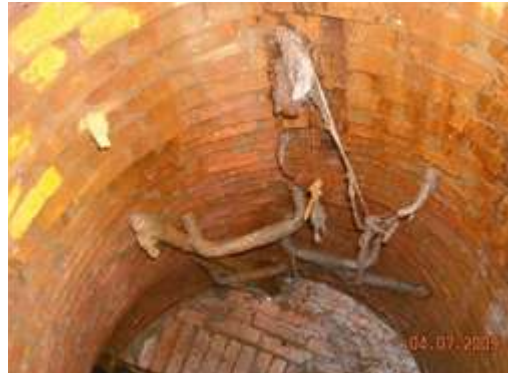
Defect 8

EVIDENCE OF SURCHARGE AT 4'
DEBRIS ON BENCH

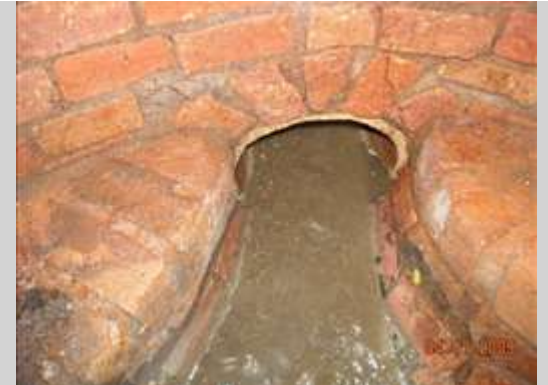
12 O'Clock Outflow

Pipe Height: **8.4** (in.) Rod and Bar (Angled)
Pipe Material: **Clay** ☐ Pipe Lined
Invert Depth: **9.40** (ft.) Flow Characteristics: **Slow**
Deposits: ☒ None ☐ Mud ☐ Sludge ☐ Debris ☐ Grease
Silt Depth: (in.) Deposits Extent:
Infiltration: **None** Pipe Seal Cond: **Sound**

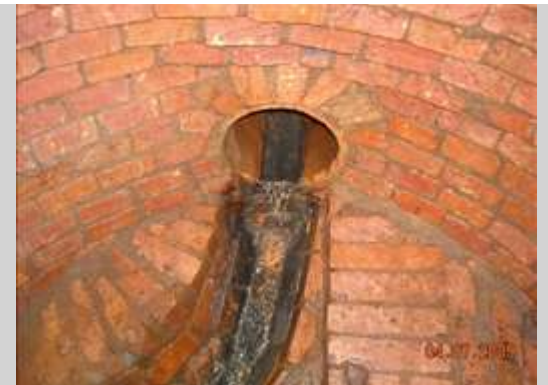
3 O'Clock Inflow

Pipe Height: **8.4** (in.) Rod and Bar (Angled)
Pipe Material: **Clay** ☐ Pipe Lined
Invert Depth: **8.34** (ft.) Flow Characteristics: **Slow**
Deposits: ☒ None ☐ Mud ☐ Sludge ☐ Debris ☐ Grease
Silt Depth: (in.) Deposits Extent:
Infiltration: **None** Pipe Seal Cond: **Sound**

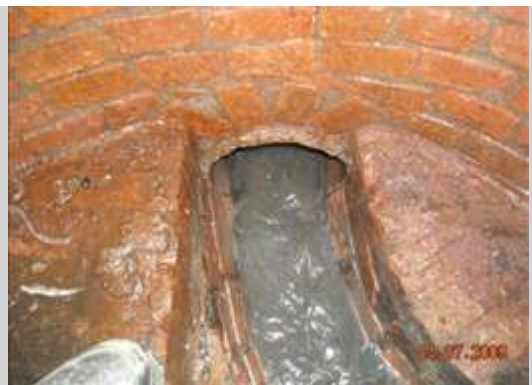
9 O'Clock Inflow

Pipe Height: **8.4** (in.) Rod and Bar (Angled)

Invert Depth: **9.15** (ft.) Flow Characteristics: **Slow**

Infiltration: **None** Pipe Seal Cond: **Sound**
